## B-04-401F 650# RENTAL BOILER

### Internal Inspection Results – Week of June 16<sup>th</sup> – 20<sup>th</sup>

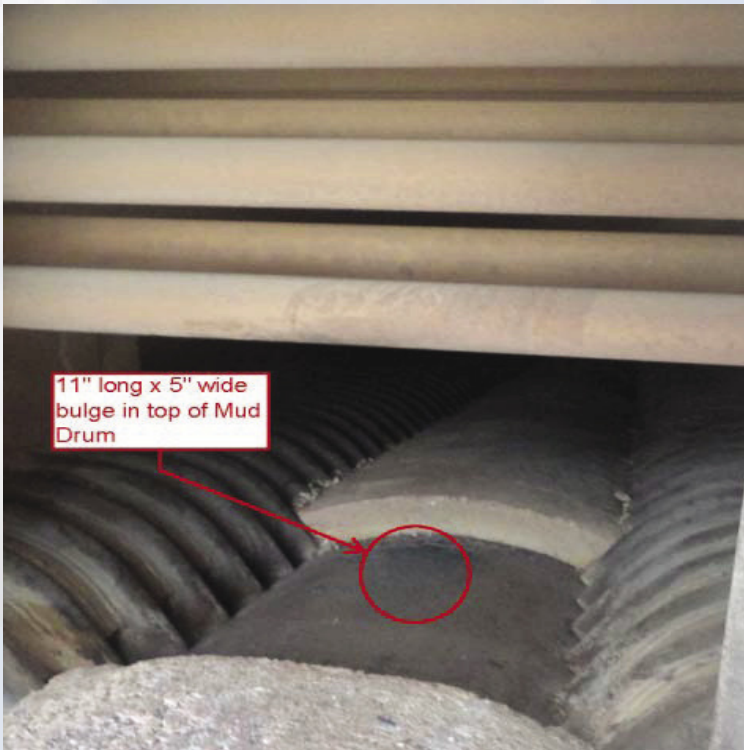
**View from top of Mud Drum**

The internal inspection of the Boiler revealed a “bulge” approximately 11” long and 5” wide located on top of the mud drop just beneath the Superheater.

11" long x 5" wide  
bulge in top of Mud  
Drum

Non-destructive Examinations were performed to reveal that there was approximately ¼” wall loss at this location on the 24” I.D. SA-516-70 mud drum with a nominal wall thickness of 1.098”. The thinned area at the bulge seem sot have occurred from the deformation of the wall and not from active erosion/corrosion issues.

After reviewing the equipment documentation and having representatives from Wabash Power Equipment Company and Optimus Engineered Products visit the site, the cause of this deformation is the lack of refractory or fire brick at this location in the boiler. Review of the internal inspection photos prior to commissioning this equipment show that the horizontal section of fire brick at this portion of the mud drum was never installed.

The normal repair of this would be to check the hardness readings of the mud drum around the area of the deformation. Once “good” metal is found, cut out a section of the mud drum and replace it in kind with a patch. Per Optimus, this repair is not possible due to the location of the deformation just below the Superheater tubes.

The repair plan is to replace the radiant section of the boiler along with the steam and mud drums. This section is approximately 30’ long x 11’ wide x 14’ high.
